AFCC TECHNICAL REPORT

PROTOTYPE FIBER OPTIC SYSTEM
TO
REMOTE TRACALS RADARS

FINAL REPORT

30 JUNE 1983

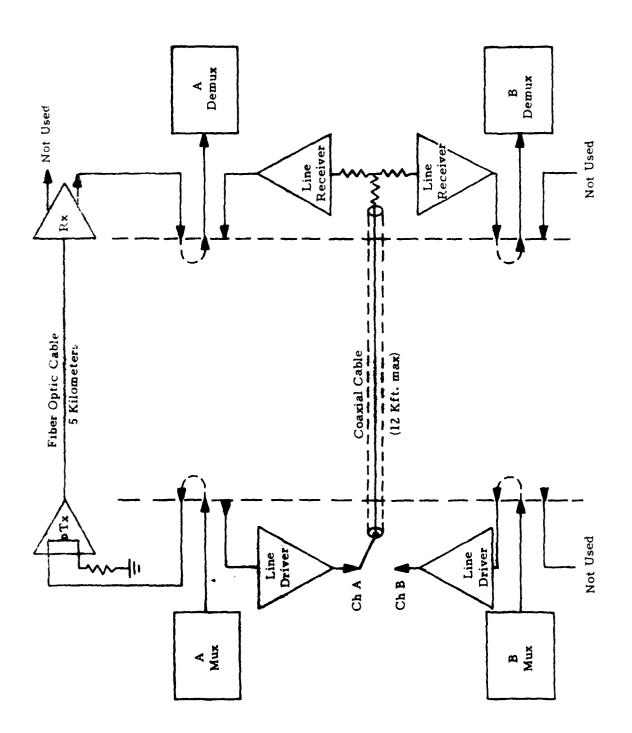
Figure 3. Configuration of Prototype Installation

- 4.3 The FO system consisted of modulator, transmitter, receiver and demodulator modules for each link. (radar shelter to the operations center/operations center to the radar shelter). A chassis, with power supply was installed at both locations to house the modules (see figure 2). The equipment installation required no modification to the radar. The connections to/from the AN/FPN-62 were made through existing BNC jacks (optional hookup for radio remoting) and thus channel A was provided the option of remoting via coax or fiber optics through repositioning 2 ea coax jumpers at each location (see figure 3). Channel B remained on coax.

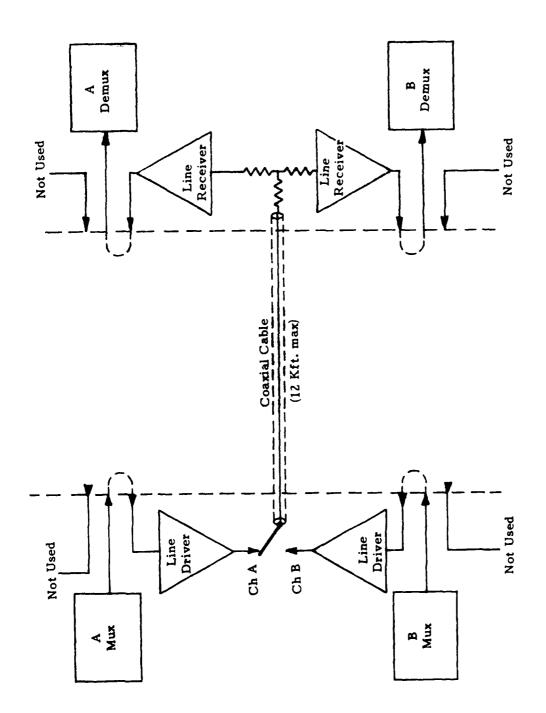
Figure B2. Normal Coax Cable Remoting System

- 7. As shown in Figure B2 the normal coax remoting system applies remoting signals from the selected Mux to both the Ch A and Ch B Demux through a resistive divider. By disconnecting the input to one Demux channel we found that channel selection and other functions were normal. Only the radar indicator sweeps were missing when that channel was selected. This meant that each Demux would act as an on-line backup to the other channel for Servo and Control data. This also meant that if the selected Demux failed to accept the control signals the malfunction would not be observable because the on-line backup would complete the operation.

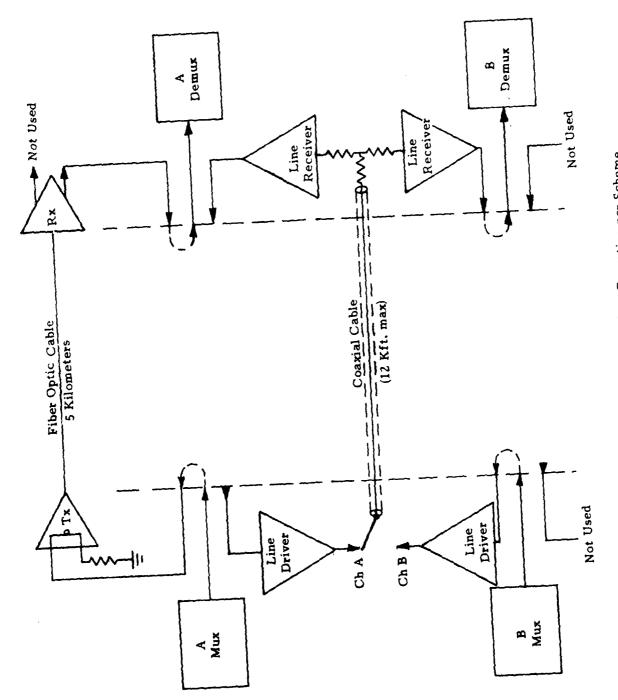
Figure B3. Combination FO and Coax Remoting per Scheme

- 8. The FO link applied the signal only from ChA Mux to ChA Demux with no crossfeed to ChB. With the insight gained from paragraph 7 above we had a possibility of a failure in the ChA Demux resulting in system malfunction when remoted by FO and not being observed when remoted by coax. This theory was tested on coax remoting by first disconnecting ChB Demux. Channel A selection failed occasionally just as it had on FO.

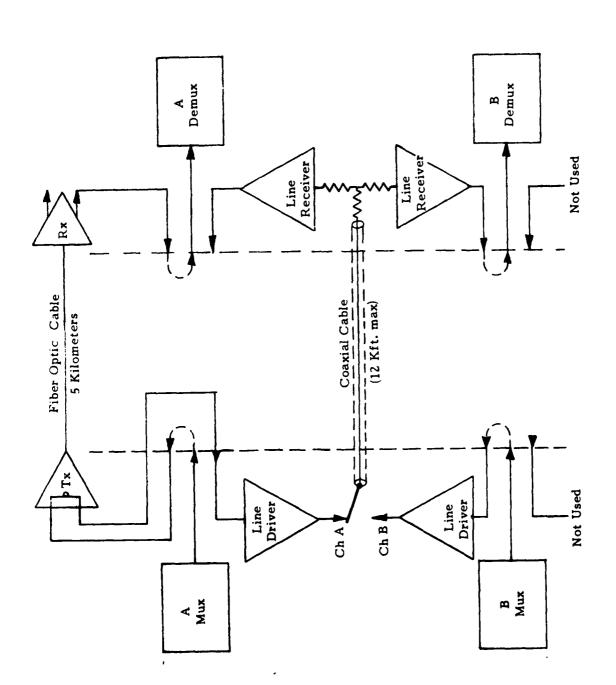
Figure B4. Modified Configuration Allowing Channel B Demux to Function as On Line Back Up

- 9. We connected the Ch A Mux output to both the FO and coax (See Figure B4). This allowed Ch A Demux to receive over FO and Ch B Demux to receive over coax when Ch A was selected. Channel A selection functioned properly. This demonstrated that when the intermittent failure occurred in Ch A Demux, Ch B Demux acted as an on-line backup.
